COMMISSION FOR HISTORICAL & ARCHITECTURAL PRESERVATION

STAFF REPORT

REQUEST: Replace stair railings

ADDRESS: 115 & 117 E. Montgomery Street (Federal Hill Historic District)

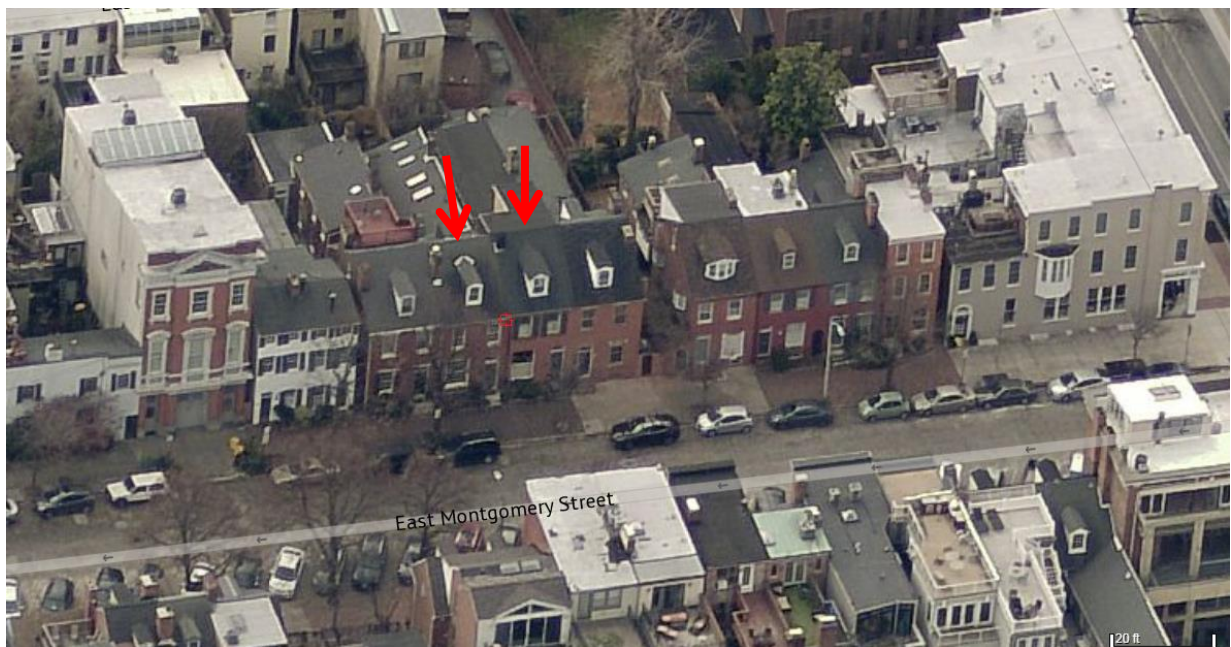
The existing properties are two-story masonry rowhouses with single dormers in a row of four dating to the 1840s (*Image 2*). The facades of both houses have likely been altered with the insertion of large windows at the first floors. 117 E. Montgomery has segmented arched masonry lintels over a large 15-over-15 window and six-panel door at the first floor approached by three marble steps with two simple metal stair railings. 115 E. Montgomery has flat splayed masonry lintels. It has a large, wide 1-over-1 window and contemporary single-pane door approached by three brownstone steps with a single simple stair railing (*Image 3*).

Image 2: Aerial view of 115 & 117 E. Montgomery Street from north, December 2017

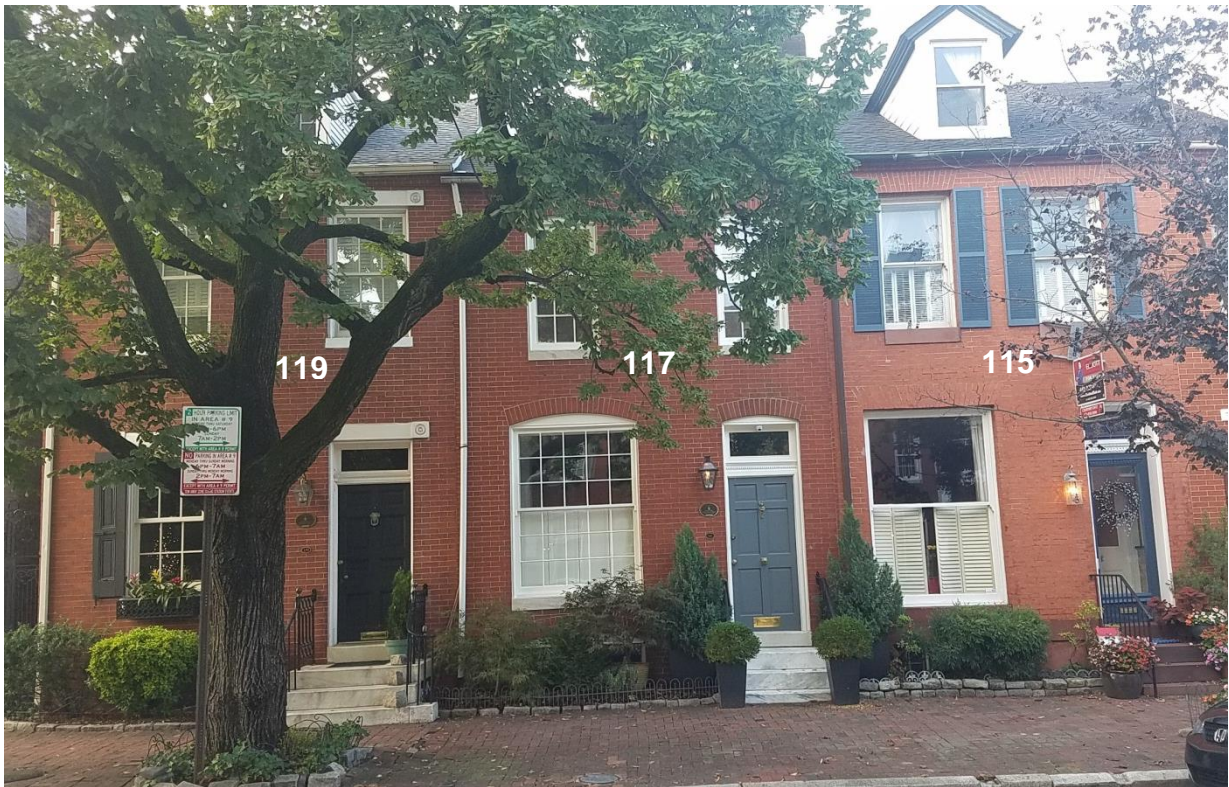
Image 3: 115, 117, 119 E. Montgomery, front elevations, July 2018

CHAP staff finds that the application fails to make the case that the proposed style of replacement railings would have been installed at 115 and 117 E. Montgomery. In the absence of historic documentation, staff recommends the retention of the current railings.

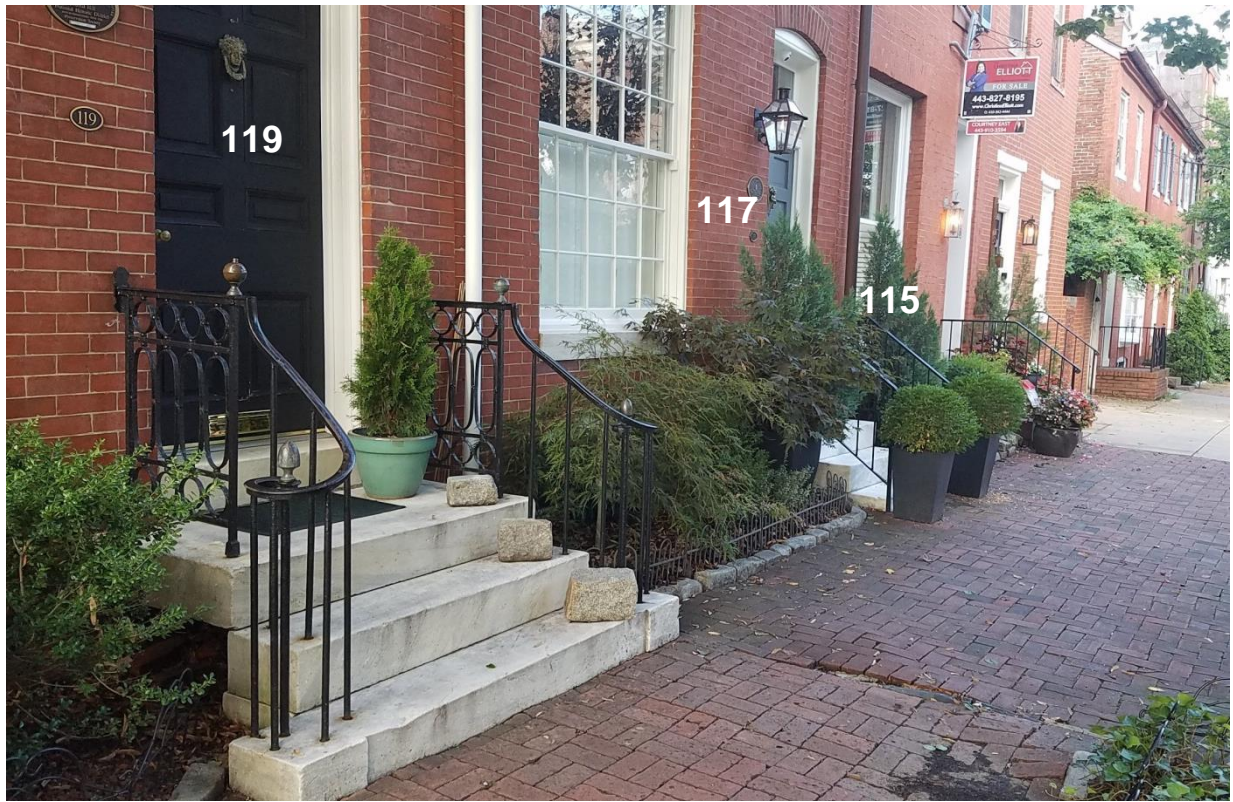
The applicant proposes to replace the existing metal stair railings at 115 and 117 E. Montgomery Street with railings that replicate the railing design at 119 E. Montgomery Street (Image 7). The initial application also requested the installation of 18” high railings at the front garden edges and around the two street trees to replace the wire and plastic material currently in place, which staff agreed to approve pending review of the design. Therefore, the stair railing replacement is the only part of the application before the Commission.

Image 7: Railings at 119 E. Montgomery, detail, July 2018

The railings and steps at 119 E. Montgomery chosen by the applicant as the model for replacement railings at 117 and 115 E. Montgomery were installed during the 1980s and came from a house in Otterbein, according to the owner of 119. There is no other documentation about the railings that may have existed here or at the other two properties. In the absence of such documentation, in accordance with the guidelines, the replacement railings should be as simple as possible, and not present a false history.

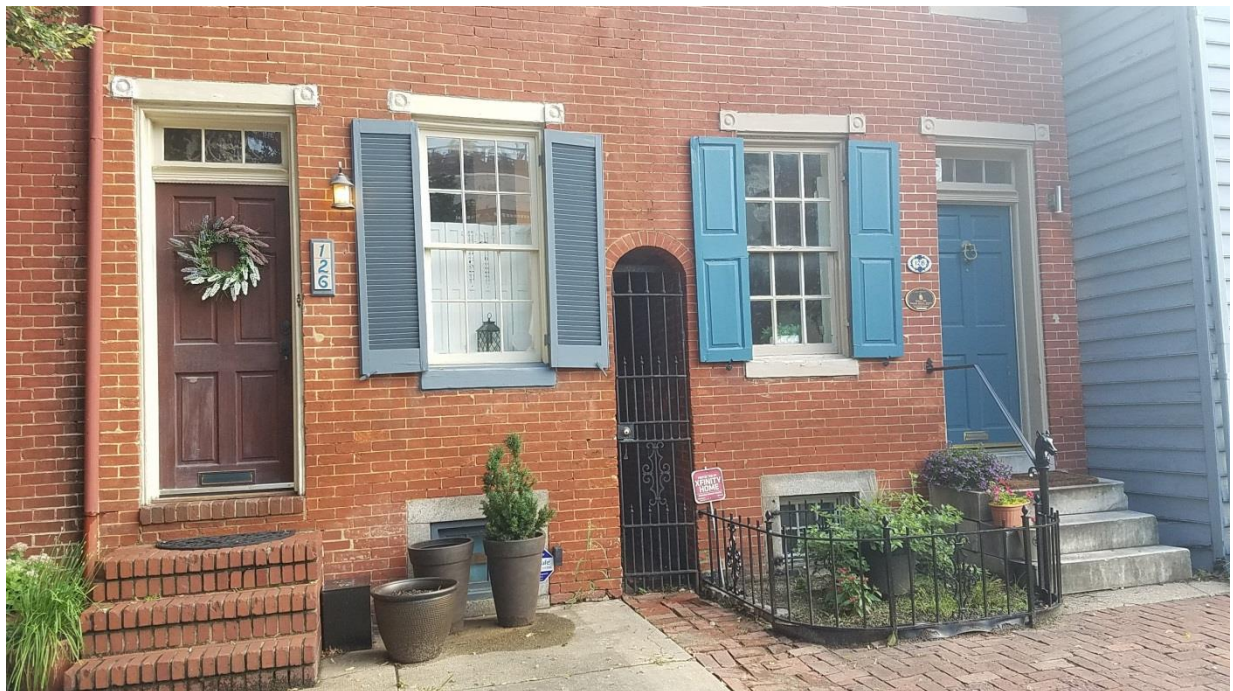
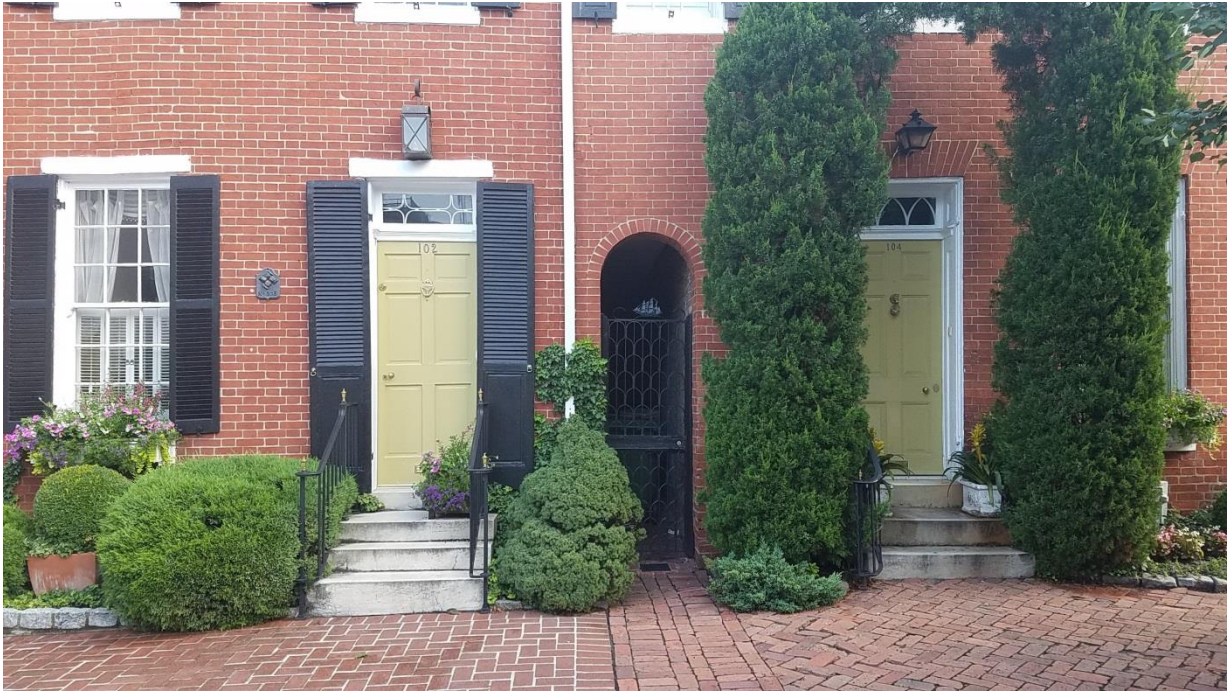
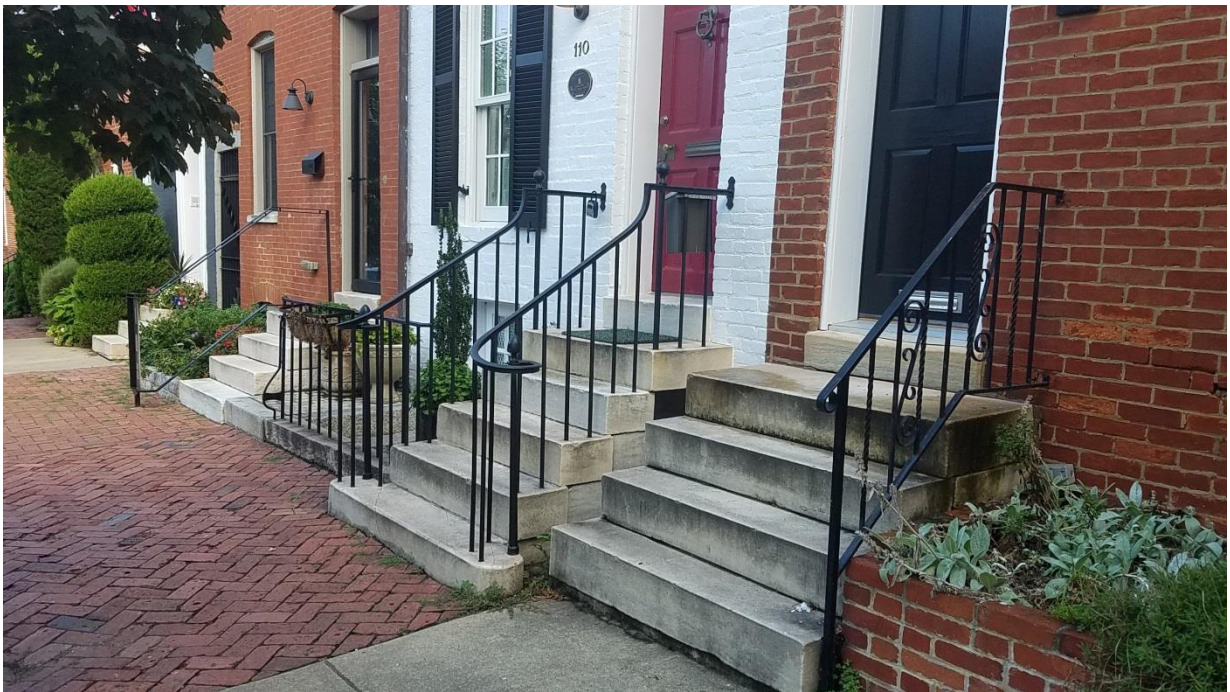
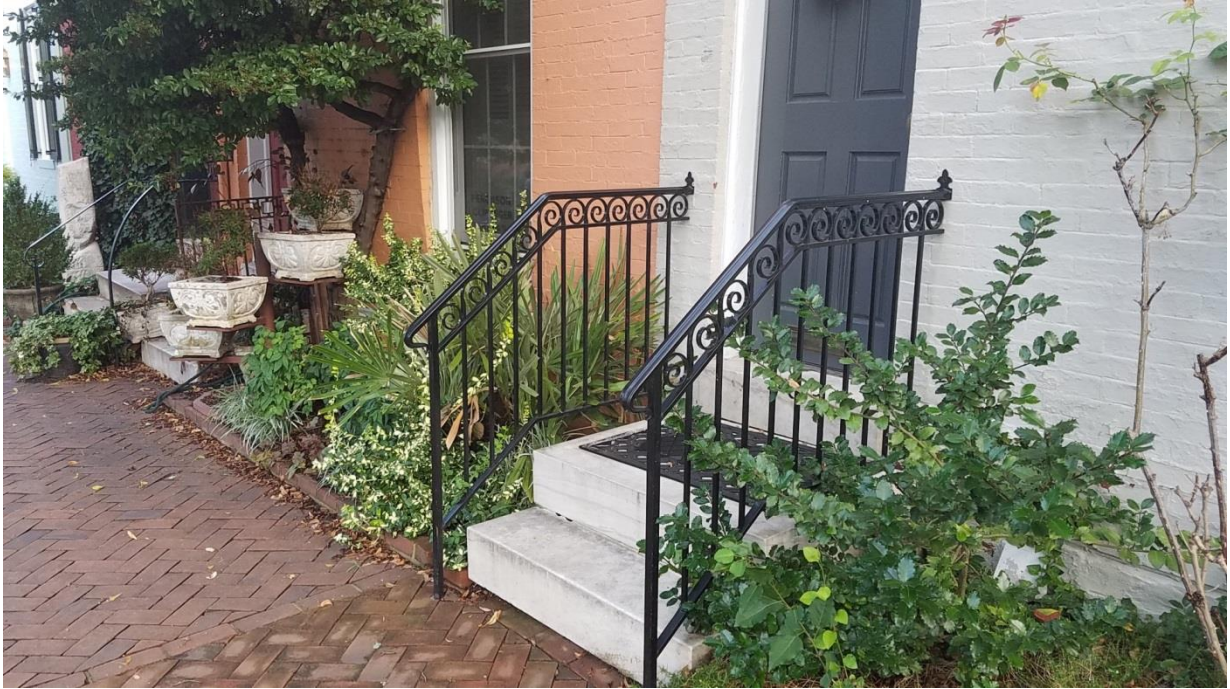
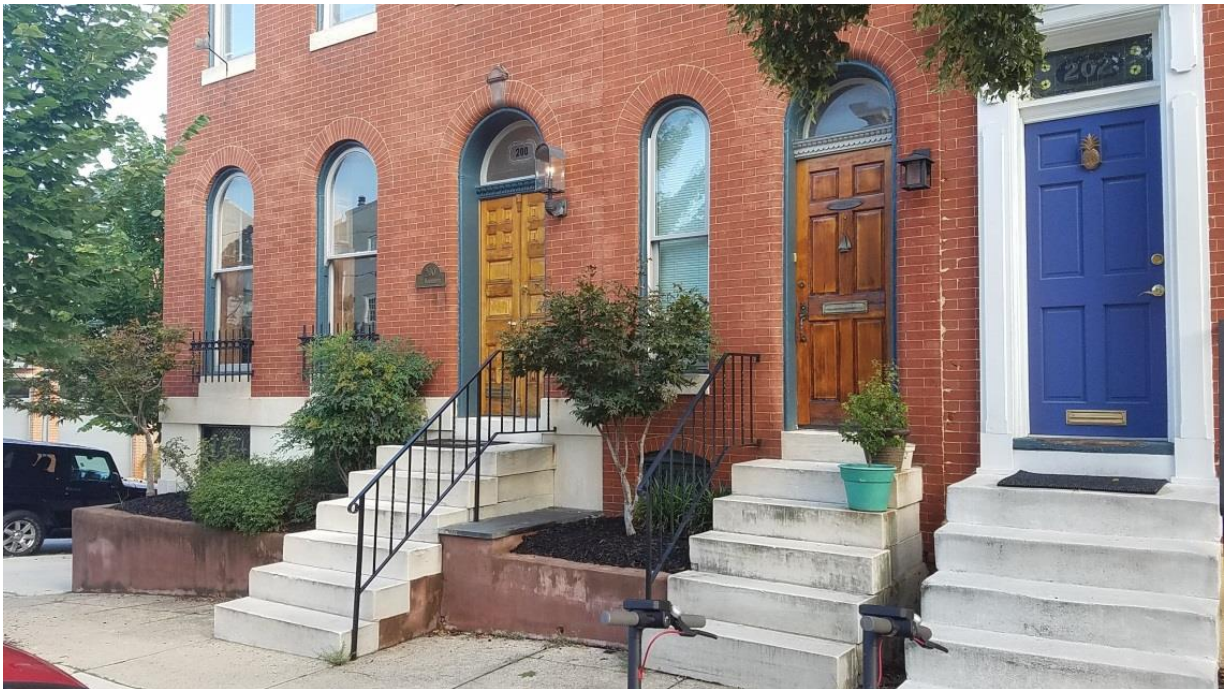
One can find a range of stair railing styles in the 100 block of E. Montgomery Street, from the ornate style of 119 to the spare contemporary style of 108 E. Montgomery across the street—and everything in between. Some stairs have no railings at all (*Images 8-12*).

Image 8: E. Montgomery Street stairs and railings, July 2018

Image 9: E. Montgomery Street stairs and railings, July 2018

Image 10: E. Montgomery Street stairs and railings, July 2018

Image 11: E. Montgomery Street stairs and railings, July 2018

Image 12: E. Montgomery Street stairs and railings, July 2018
